Sewer System Evaluation

PALMETTO ESTATES COLLECTION SYSTEM

Beaufort, South Carolina

Blue Granite Water Company

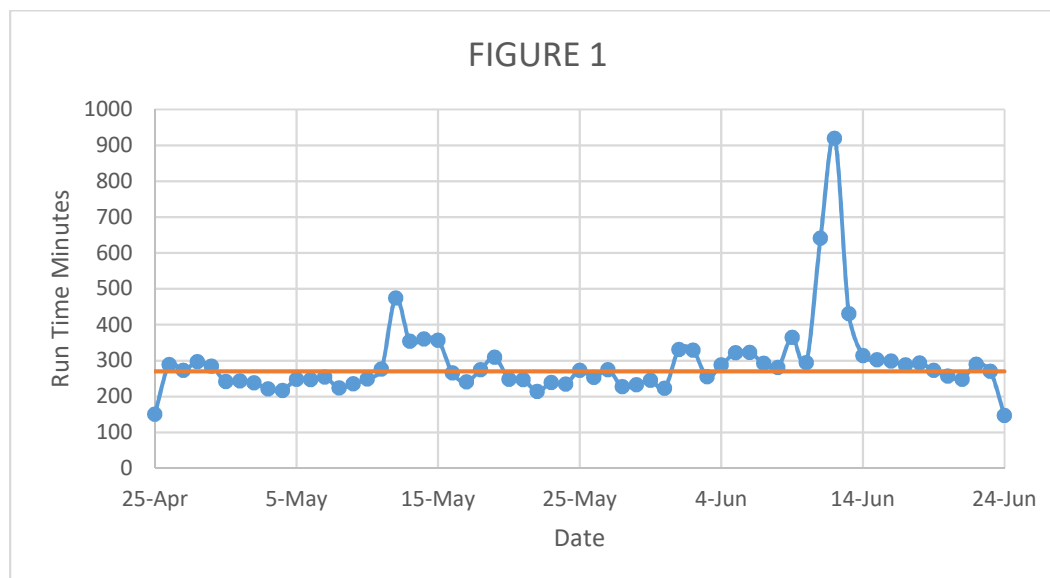
BJWSA provided pump run time data for the SP04 lift station. Based on the data provided, the lift station should operate for 275 minutes (4.6 hours) per day. During periods of peak flow, the lift station experience peaks of up to 3.4x. While there is a peaking factor associated with the system from inflow, it is also assumed that the baseline flow may be elevated due to influence from groundwater. The run time can be seen in Figure 1 below.

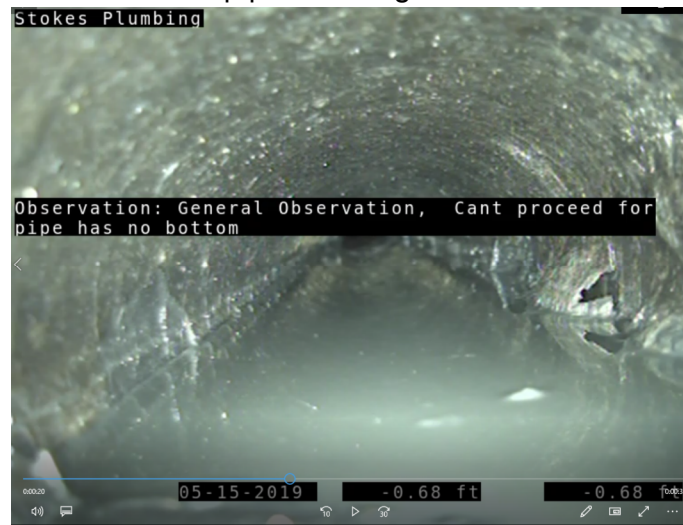
1. The Bottom of the pipe is missing between two manholes.

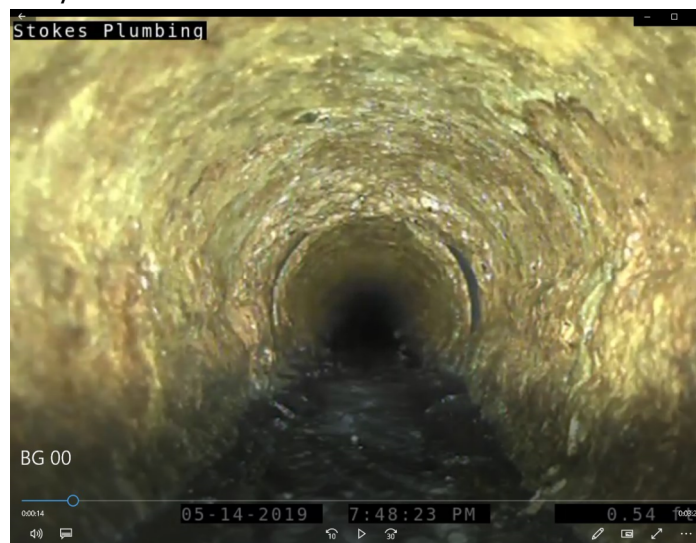
2. Scaling of the pipe has occurred in the DIP sections of pipe. This occurs in two runs of pipe totaling approximately 60LF.

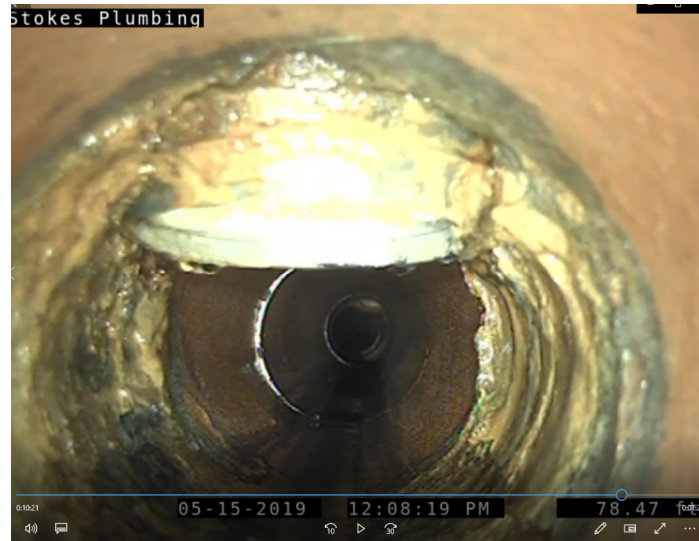
3. Protruding taps and incorrectly installed taps hinder maintenance and allow roots and infiltration into the system. This happened in one clay pipes between 2 man holes and involved at least three taps.

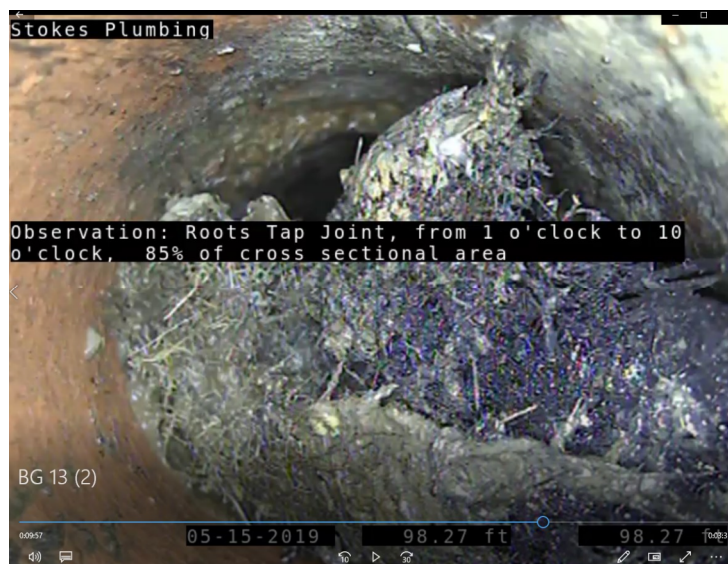
4. Displaced Joints. These were present in all clay pipe runs, with 3 joints having roots entering the system. There are 5 runs constructed of clay pipe totaling approximately 829LF of pipe.
